**SHORT TITLE:** Resolution to Approve Air Quality Upgrades and Moisture Remediation in the Pender County Jail and Authorizing Purchase Order to Tim's Heating & Air Inc.: \$29,229 and Eastern Environmental, Inc.: \$19,850.

## **Property Mold Assessment**

Pender County Jail  
104 N. Walker Street  
Burgaw, NC

RE: AQA Job # 11-107-0615, Property Mold Assessment, Pender County Jail, 104 N. Walker Street, Burgaw, NC.

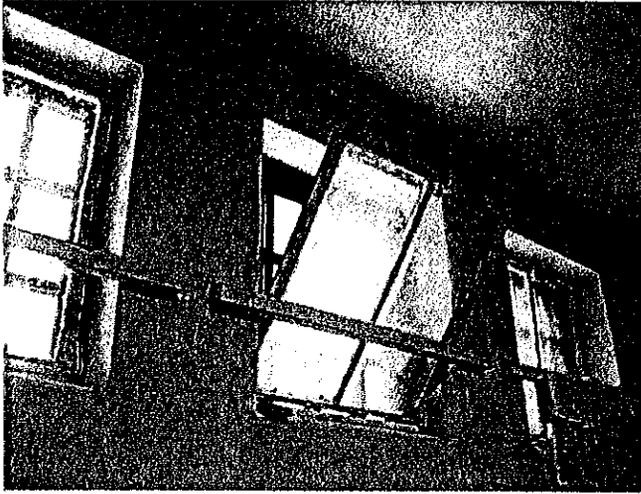
5 Men Cell: Mold growth at windows

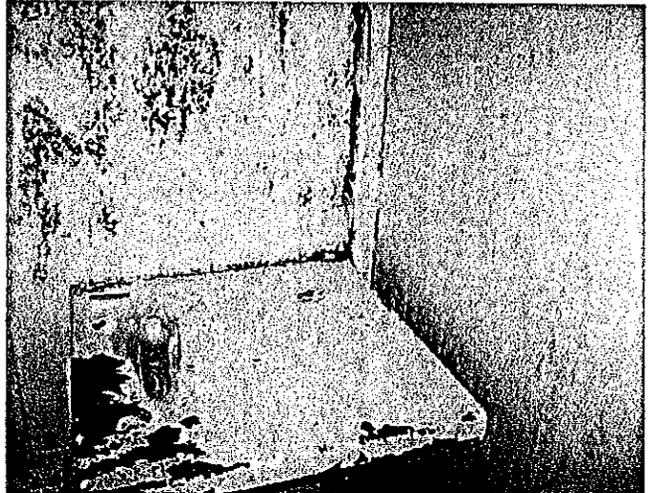
Rust and mold in cell area

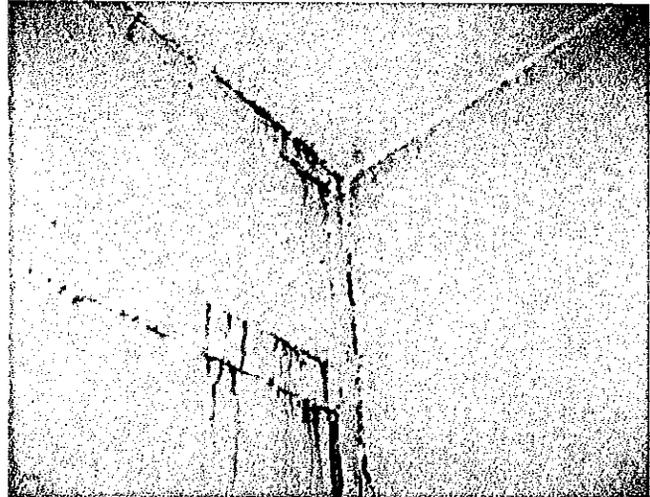
2. Heavy rust on metals and efflorescence of calcium salts from concrete walls is present in the older sections of the jail where sustained condensation and humidity is occurring.

Rust due to chronic condensation

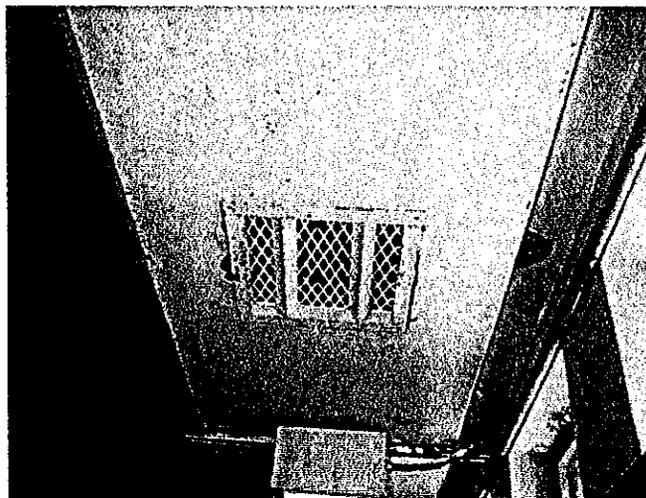
Supply line in the Hallway

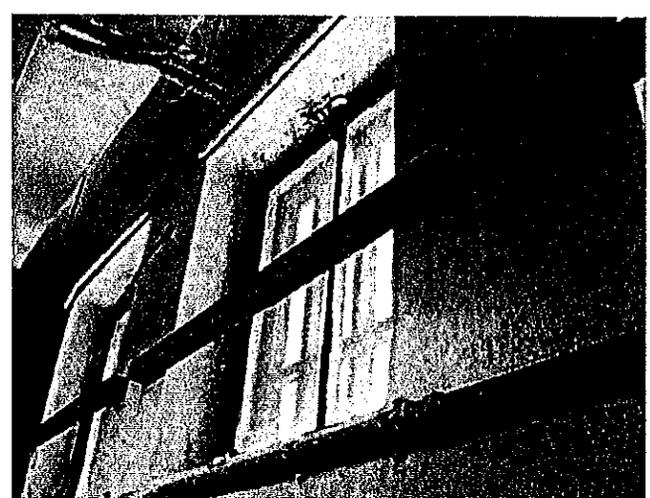
Rust and mold at windows

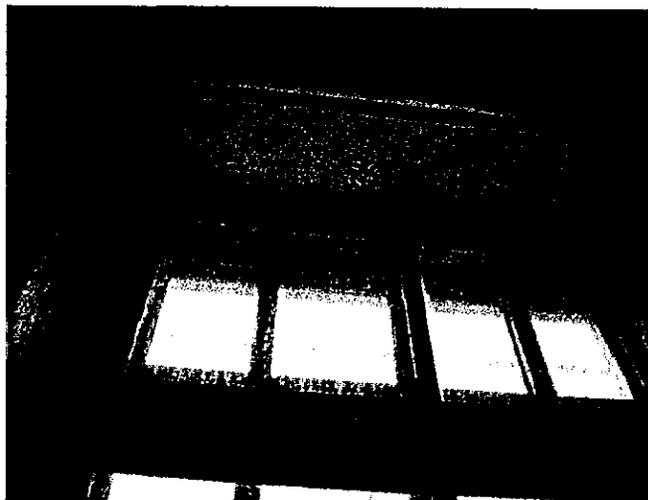
Heavy mold growth around windows

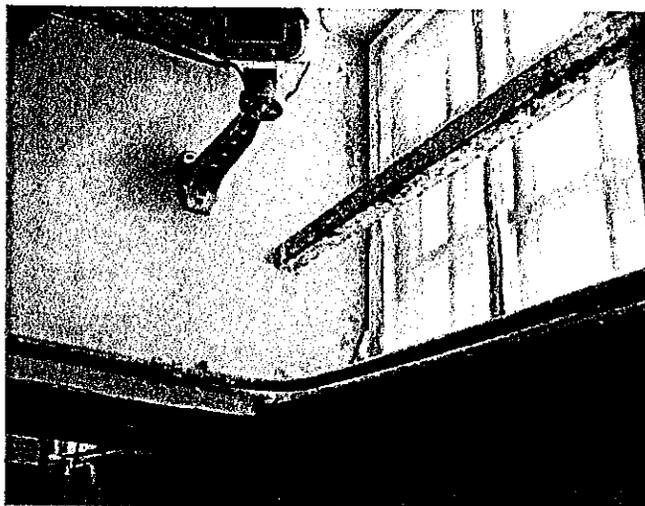
Water damages around window

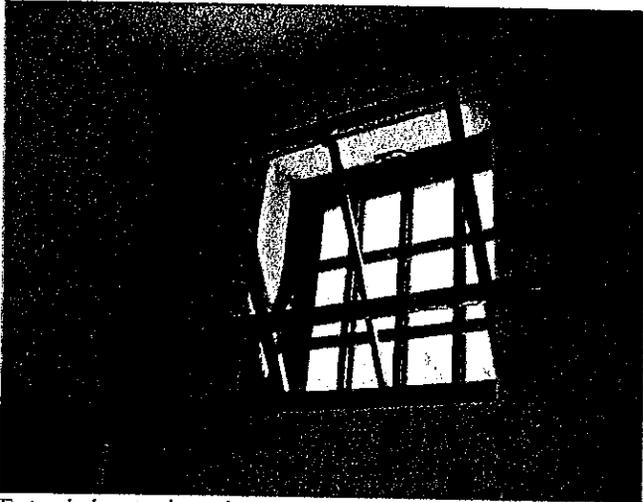
Extended water intrusion

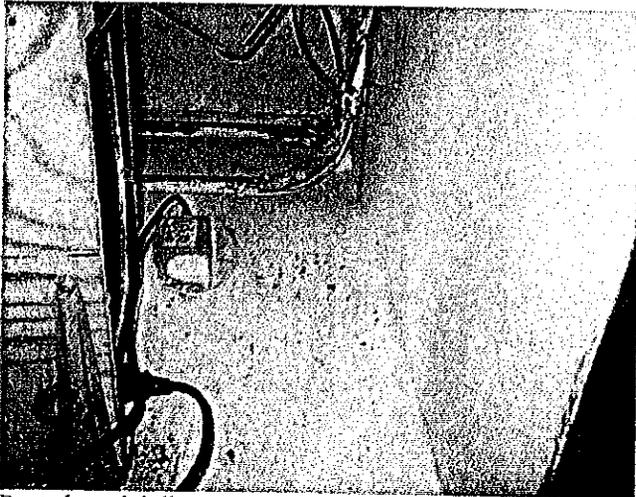
Rusted conduit lines

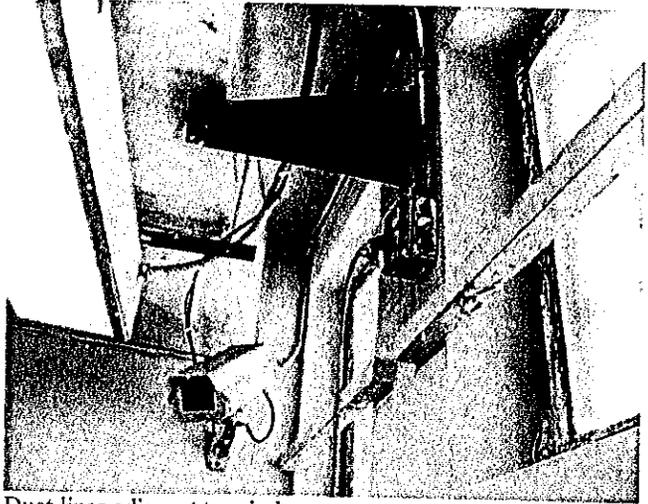
Duct lines adjacent to windows

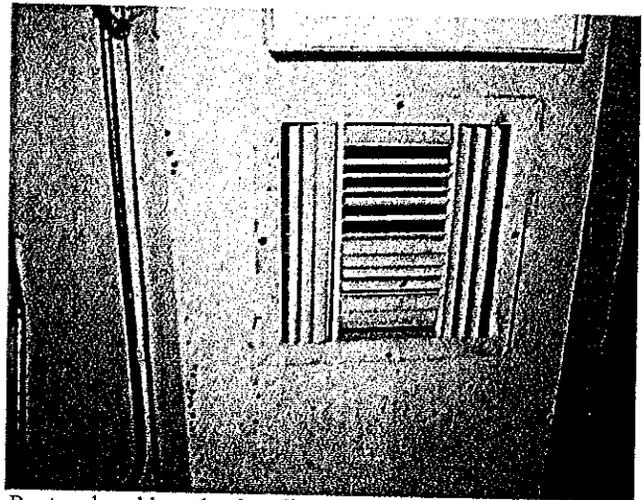
Rust and mold on the duct line
