SHORT TITLE: Presentation of Calico Bay Drainage Maintenance Project

March 14, 2011

Background and History

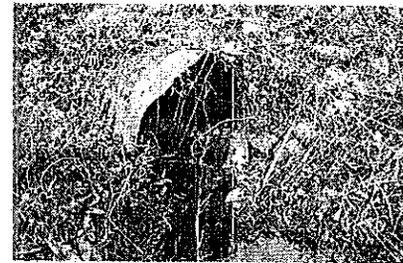
Culvert pipe opening upstream or east of Calico Bay Rd.

In general, the condition of the culvert pipe is good with minor sediment buildup within the bottom of the culvert profile. The ditch downstream of Calico Bay Rd

The drainage structures and ditches within the DOT right of way is the responsibility of the Department of Transportation to maintain in a good working condition in order to protect the integrity of the road and the safety of the traveling public. The DOT has agreed to clear the ditch and culvert pipe located within the right of way. This work will improve the flow leaving the Calico Bay area.

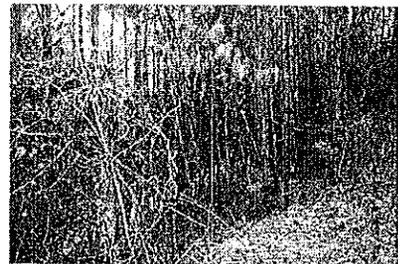
The ditch profile has a healthy growth of native vegetation on the banks.

The growth of native vegetation on the banks of the ditch should be allowed as long as the trees and plants do not impact the function of the ditch to move water downstream or prohibit access for maintenance of the ditch. The plant growth observed on the banks during our inspection does not appear to be an issue with the exception of some trees located at or near to the normal water level.

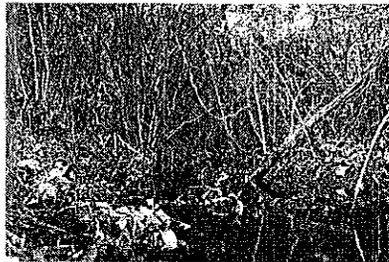
encroaching into the bottom of the ditch profile and if left

unattended will trap debris that is floating in the stormwater. The debris observed during the inspection was organic, such as sticks and leaves, and inorganic, primarily trash and items washed from residential yard areas or items discarded that have somehow migrated into the ditch.

Vegetation is encroaching into the bottom of the ditch profile...

These plants should be reviewed on a case by case bases and vegetation which is acting as a trap or flow obstruction should be cut flush to grade. It is not necessary at this time to remove any root material or bank growth by excavation. Excavation of material within the ditch profile would involve heavy equipment and a review for approval by the Corps. All of the needed work at this time can be accomplished by hand with removal of vegetation and debris aided by trailer to haul material off site.

The plants, trees and debris located within the bottom of the ditch profile should be removed. Trees cut as low as possible will be sufficient to restore flow. Leaving the roots of existing trees within the ditch bottom and along the banks will maintain stability of the ditch profile and will avoid potential erosion.

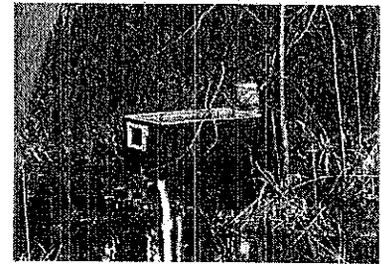
The debris observed during the inspection was organic, such as sticks and leaves, and inorganic, primarily trash and items washed from residential yard areas or items discarded that have somehow migrated into the ditch.

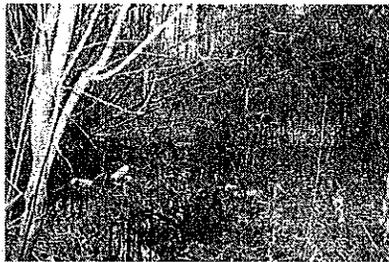
Upstream, both ditches are stable with native vegetation. Some vegetation has started to encroach into the bottom of the ditch profile similar to what was observed in the road right of way. Trash and other inorganic items were noticeable along the ditches, especially in areas closest to residential activities. It should be noted that obstructions from items were the exception. The primary obstruction to flow being the vegetation growing within the normal flow path of the ditch. This vegetation acts as a trap collecting debris which is floating in the stormwater. As debris is trapped, areas of silt, soil, and organic material are established in the flow path that provides an area that can support plant growth. As vegetation is established and root growth expands within these areas, additional material is trapped repeating the cycle.

Trash and other Inorganic items were noticeable along the ditches especially in areas closest to residential activities.
