**SHORT TITLE:** Resolution to Approve Air Quality Upgrades and Moisture Remediation in the Pender County Jail and Authorizing Purchase Order to Tim's Heating & Air Inc.: \$29,229 and Eastern Environmental, Inc.: \$19,850.

## **Property Mold Assessment**

Pender County Jail  
104 N. Walker Street  
Burgaw, NC

RE: AQA Job # 11-107-0615, Property Mold Assessment, Pender County Jail, 104 N. Walker Street, Burgaw, NC.

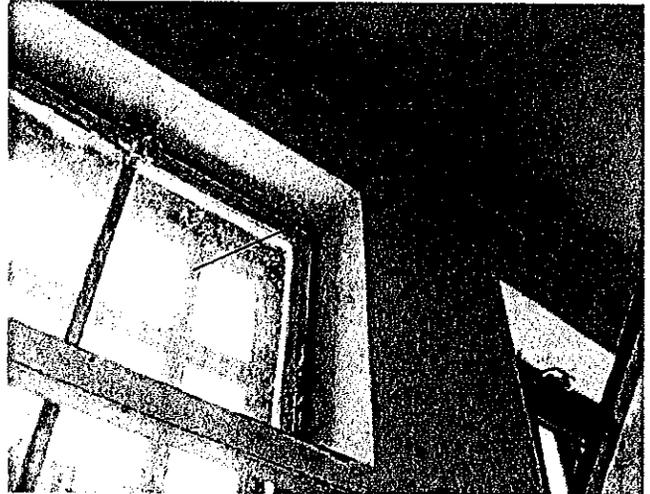
Rusted supply register

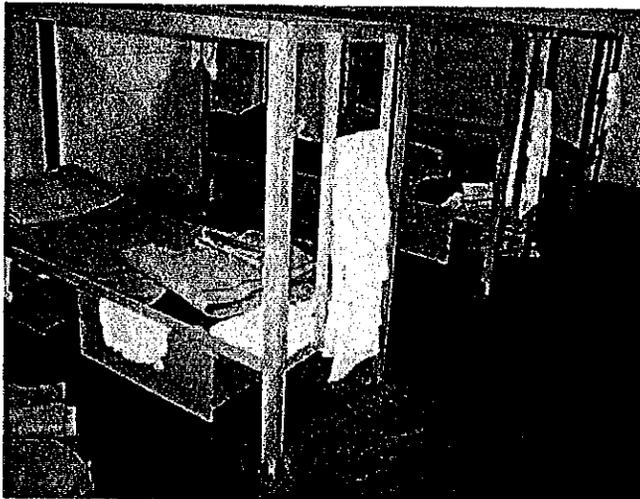
Women's Dorm cots

5. Light mold growth was observed in the Women's cell on sealant materials on the floor edges.

2. Mold growth in the Women's dorm is likely due to similar thermal conditions (air mixing); however, occurring on sealant materials at the floor base, likely due to the temperature levels at the floor base and properties of the sealant to support mold growth.

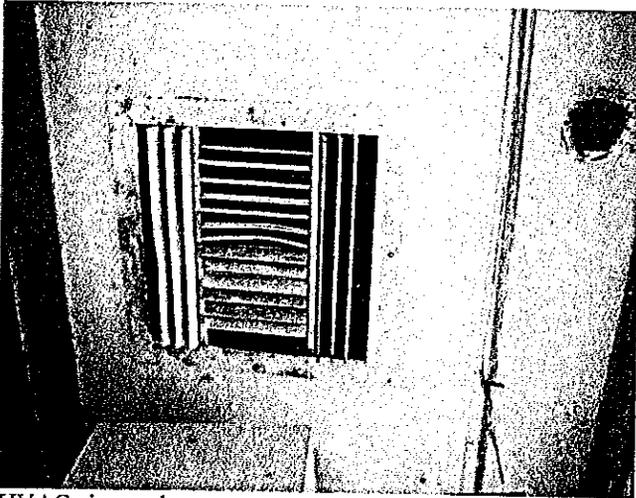
HVAC air supply

3. The air supply lines are attached to the ceilings in the hallways immediately adjacent to windows. Heavy rust is present on supply registers.
4. HVAC supply lines are not insulated on the outside but are likely insulated on the inside of the duct lines.
